Cassia Drive Stream Restoration

STREAM DESIGN REPORT

June 2026

Environmental Systems Analysis, Inc. (ESA)
2141 Priest Bridge Drive, Suite 1
Crofton, Maryland 21114

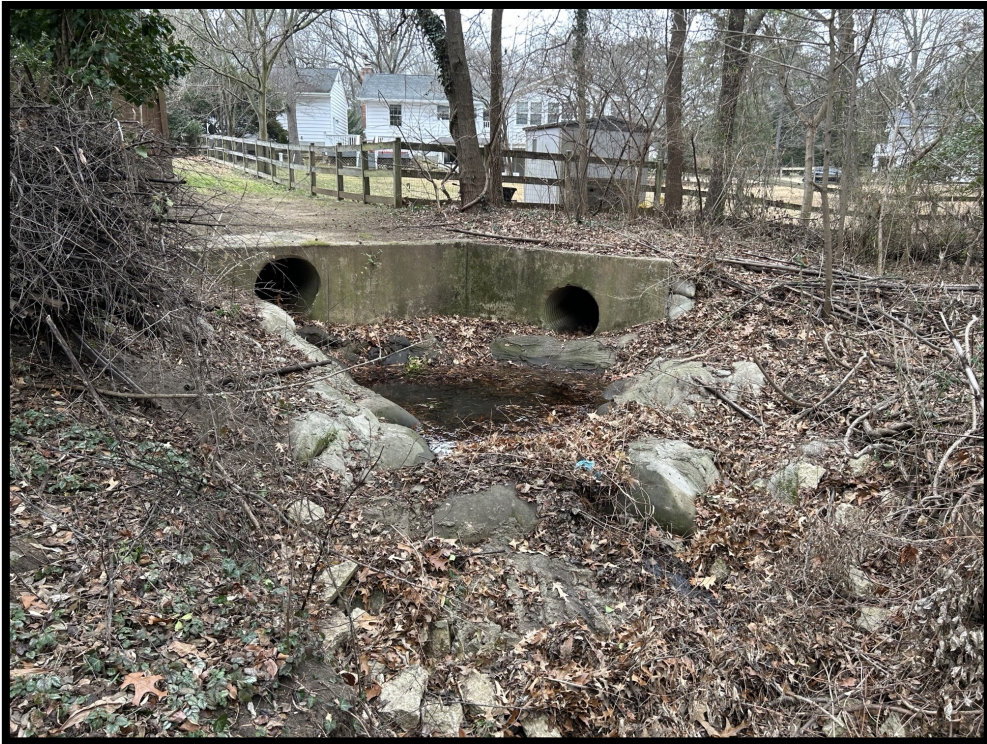
PHOTO 1: Outfalls at upstream end of project.

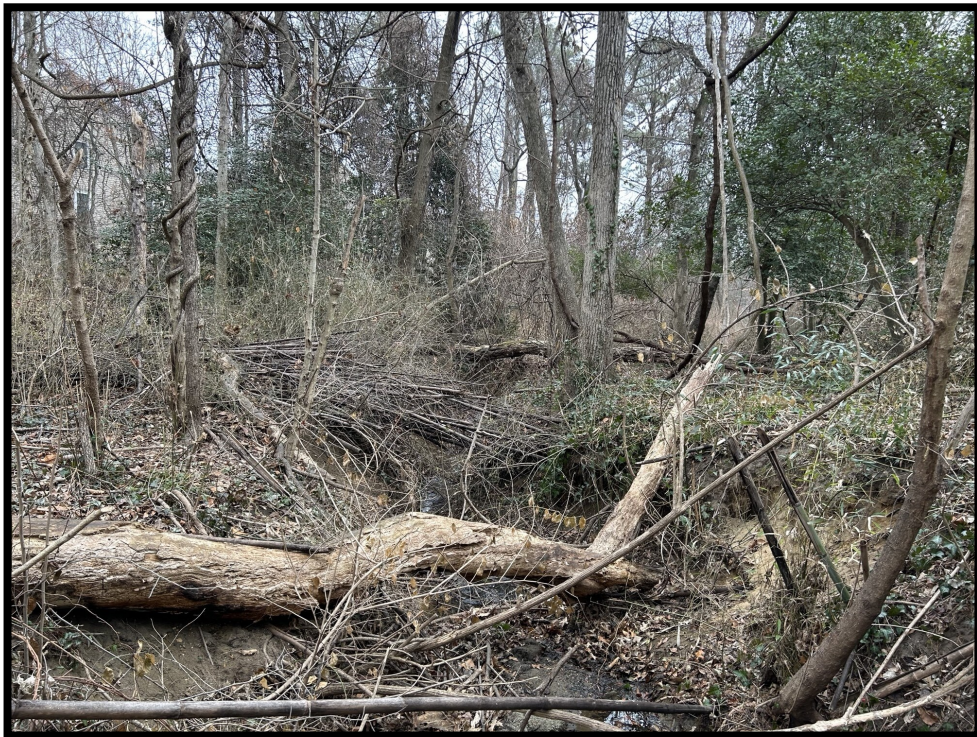
PHOTO 2: View looking downstream from the outfalls.

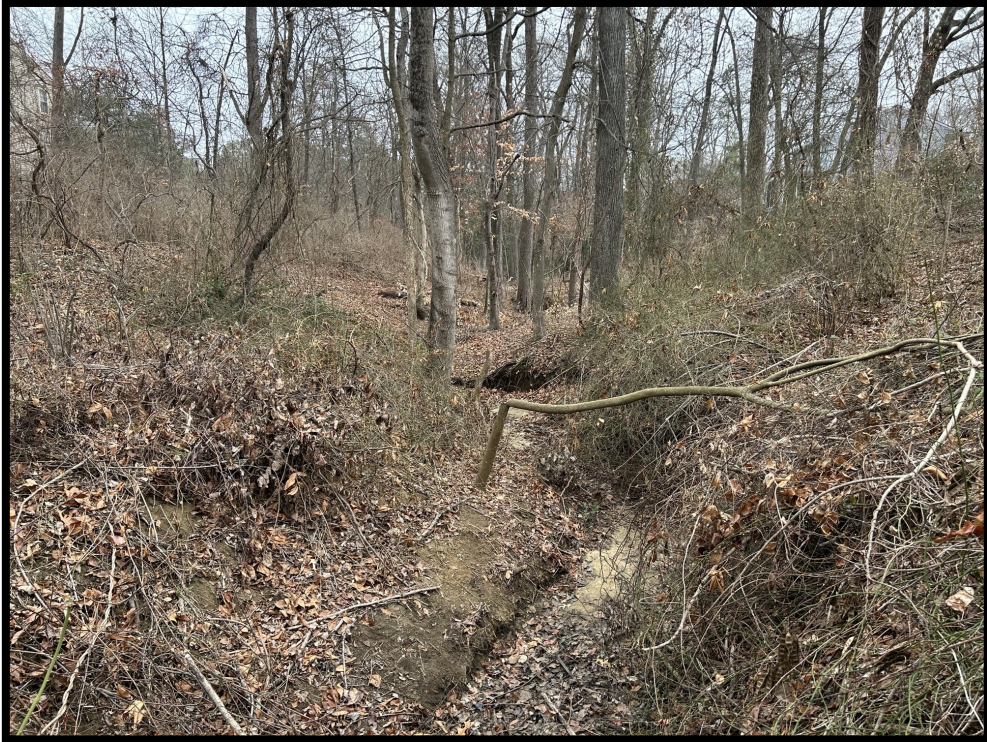
PHOTO 3: Upper end of site looking downstream.

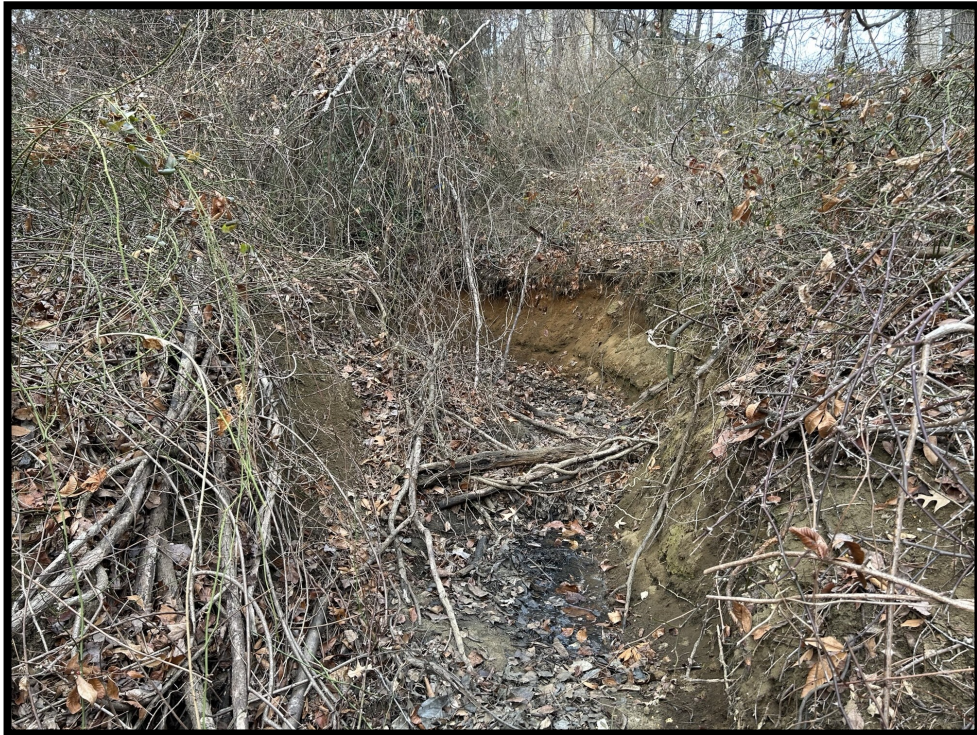
PHOTO 4: Upper end of site looking upstream.

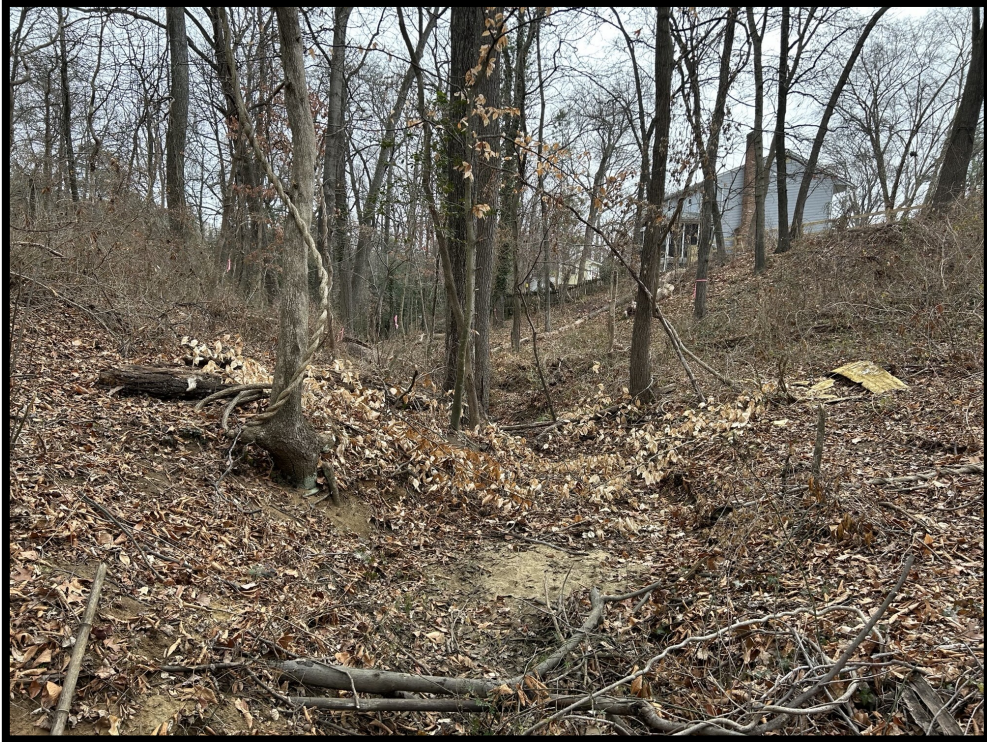
PHOTO 5: Middle of site looking downstream.

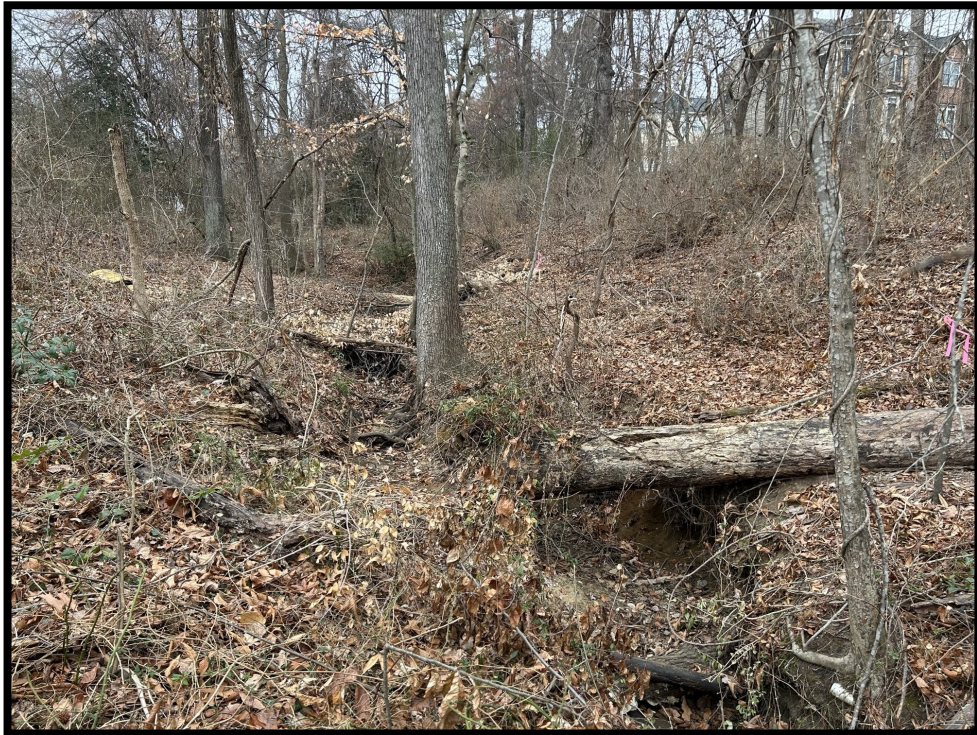
PHOTO 6: Middle of site looking upstream.

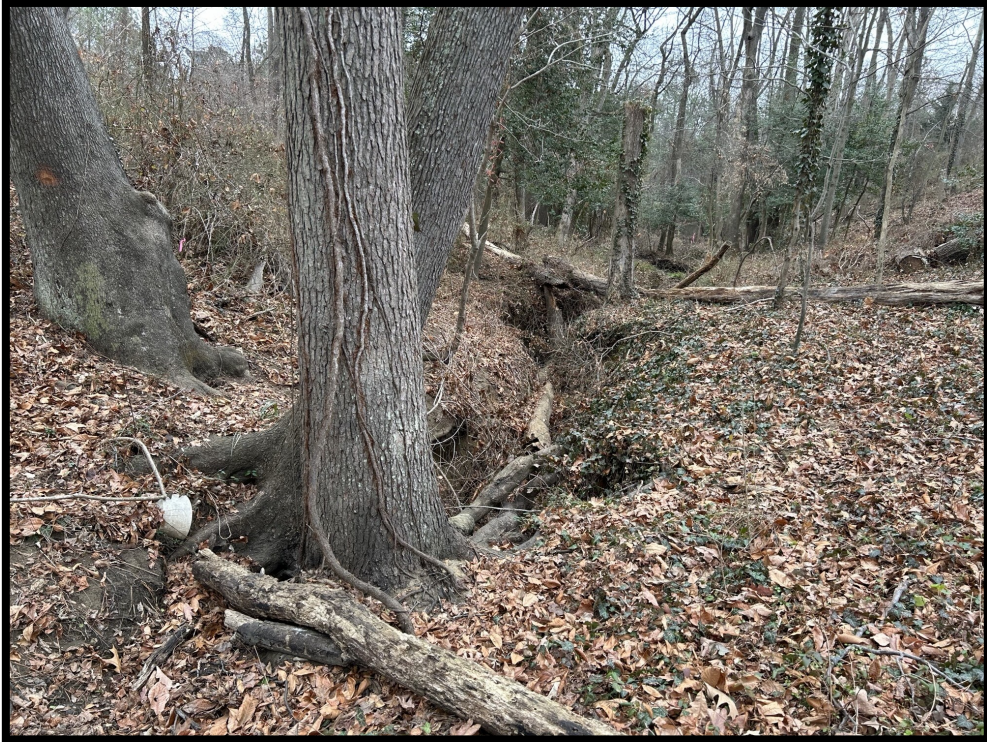
Three headcuts were observed. The largest occurs just below two 19-inch trees. Bank heights below the headcut are 5 to 6 feet for about 100 feet in the downstream direction before gradually decreasing. Below this headcut the stream transitions from ephemeral to riverine intermittent due to the significant gradient drop. Bankfull discharge (Q_{BKF}) and geomorphic channel parameters were determined and are shown in **Table 1**.

PHOTO 7: Middle of site looking downstream at two tulip trees in the channel at a 5-foot headcut.

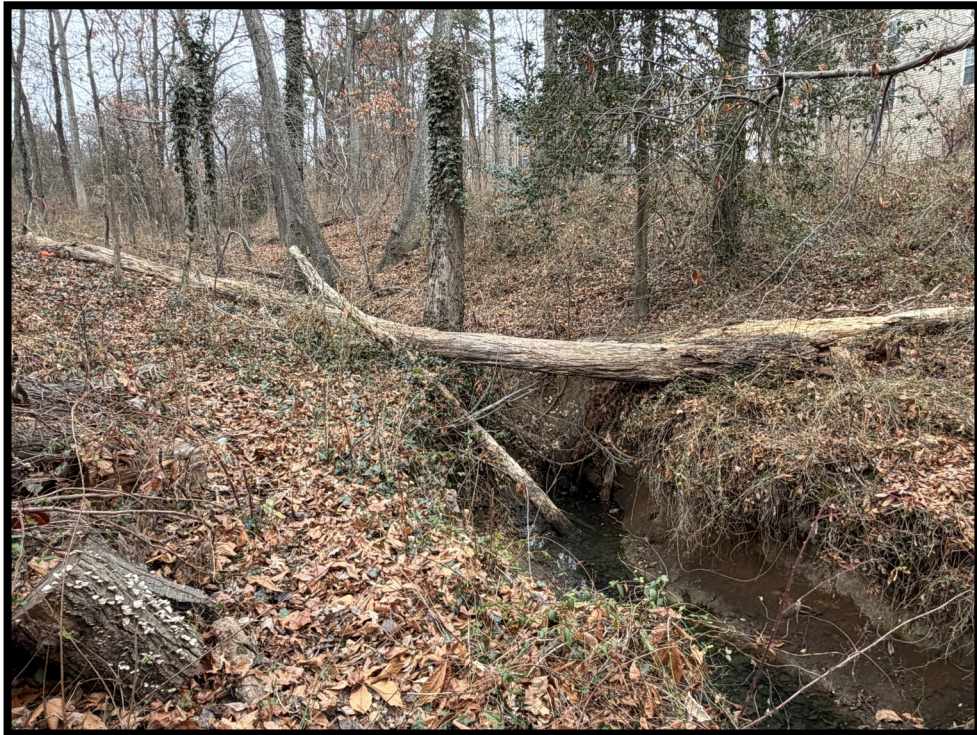
The channel is deeply incised and classifies as a narrow, unstable B5, gully morphology with sand as the dominant substrate. It has widespread vertical and lateral instability and lacks floodplain connection. The entrenchment ratios range from 1.43 to 1.78, and width-depth ratios range from 3.62 to 9.18. The overall channel slope is 0.0282. The channel is unstable and will likely continue to degrade without restoration work.

PHOTO 8: Middle of site looking upstream at incised channel below the head-cut.

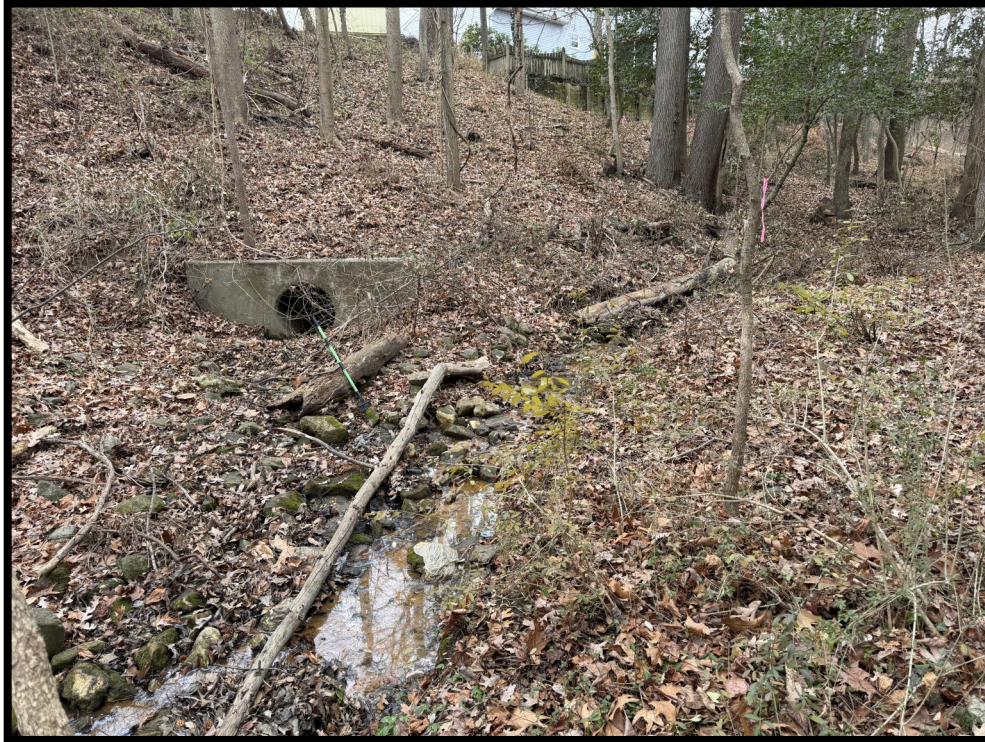
PHOTO 9: Storm drain outfall on right (south) bank at lower end of site.

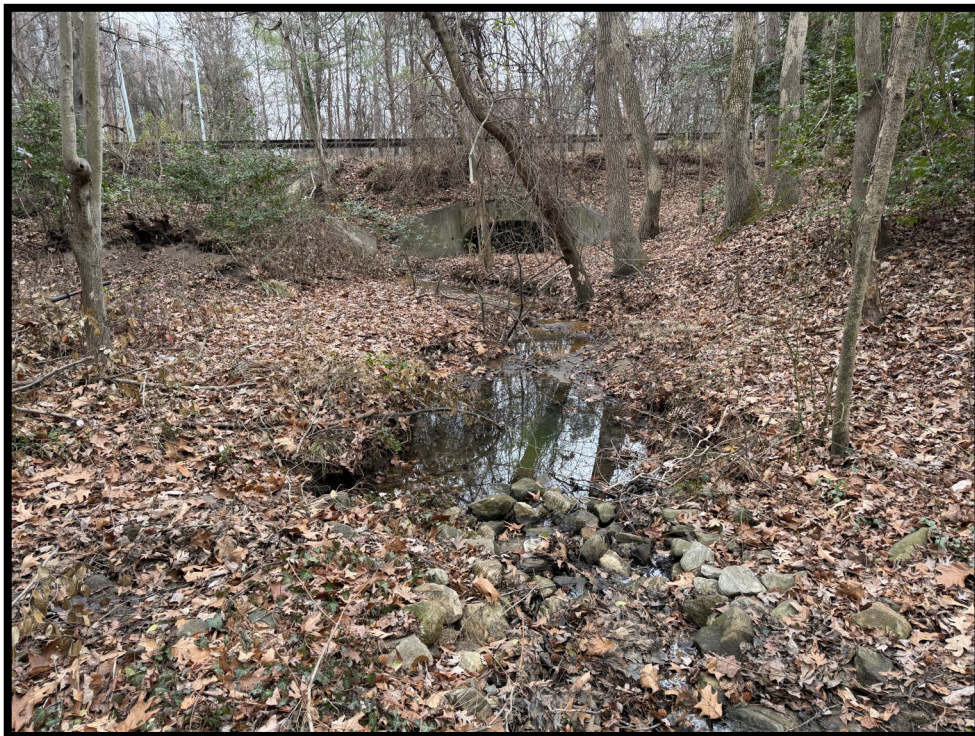
PHOTO 10: Lower end of site looking downstream at stable section towards culvert under Admiral Cochrane Drive.

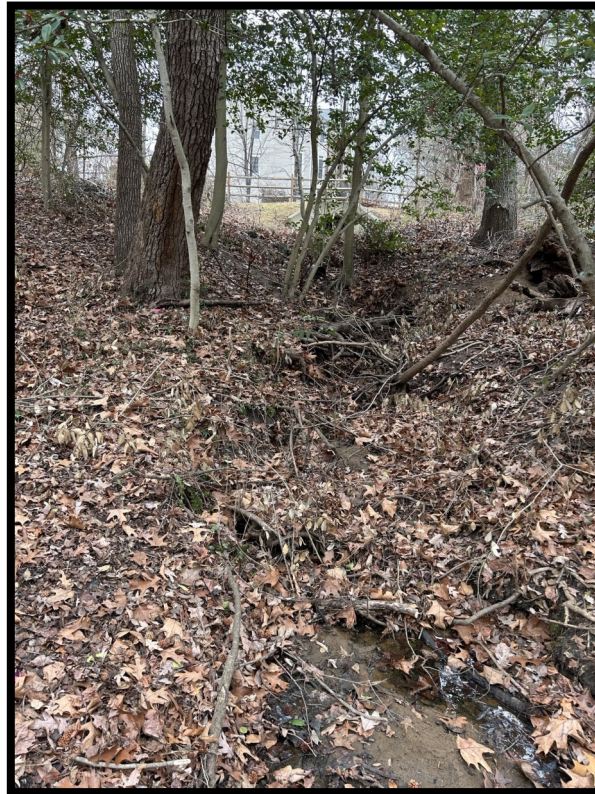
PHOTO 11: Eroded flow path below outfall from SWM pond on left (north) bank.

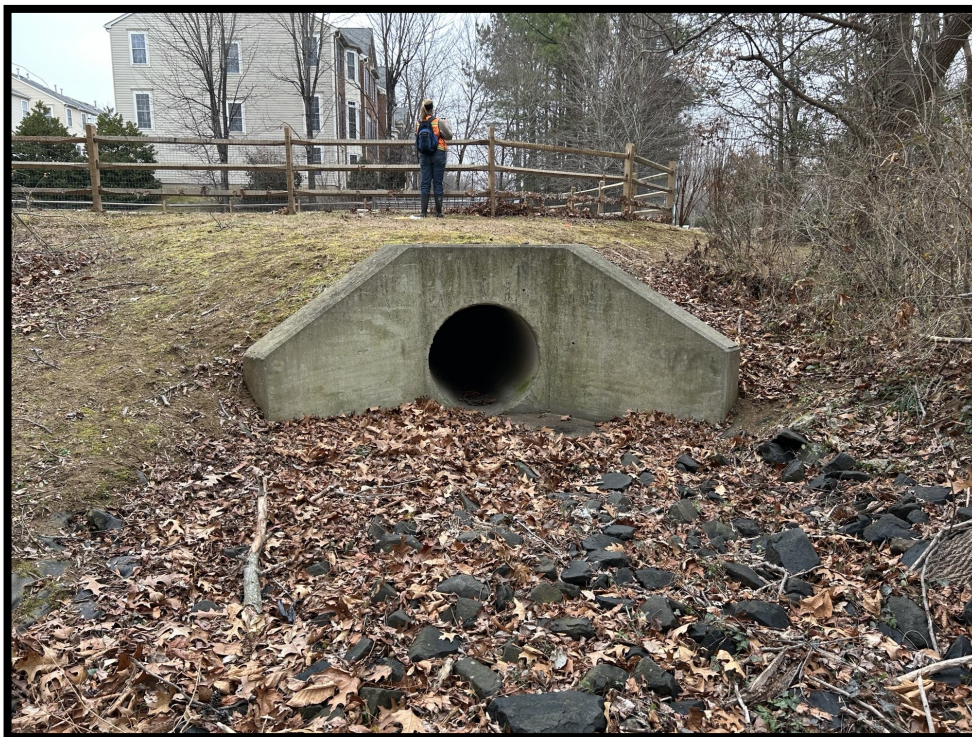
PHOTO 12: SWM pond outfall and rock apron.
